TEST REPORT

CEPRI-EETC02-2022-0036(E)

Object: 35kV AC shielded rear connected gapless metal
oxide lightning arrester

Type: GHD-35BLQ-51/134

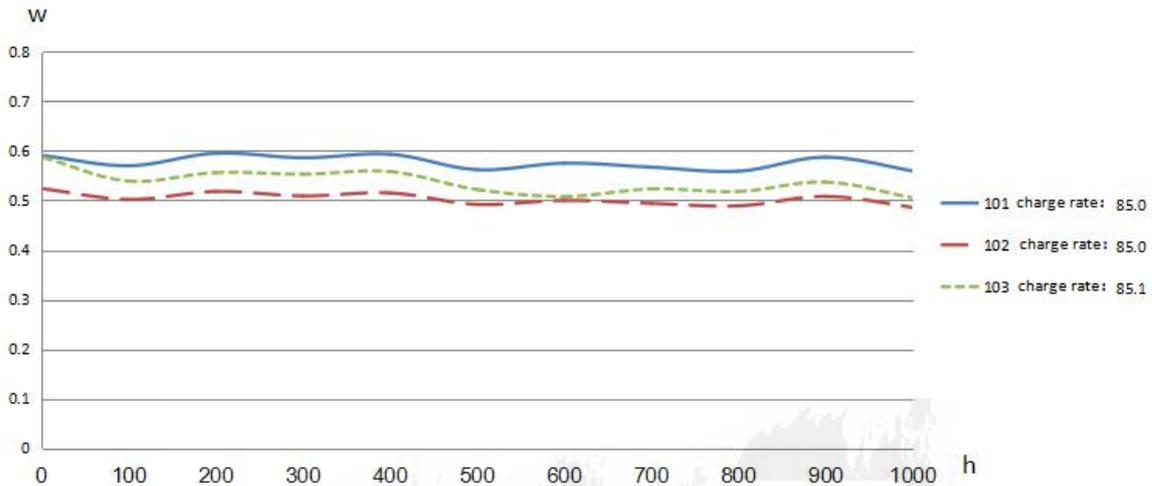
Fig 1 Accelerated ageing test curve

Test data: Fulfilled the requirements, the accelerated ageing curves were shown in fig 1.

Samples	101	102	103
U_{1mADC} , kV	5.04	5.06	5.02
U_c , kV _{rms}	3.04	3.04	3.04
Charge rate,%	85.0	85.0	85.1
Power losses P_{start} , 3h, W	0.590	0.523	0.586
Power losses P_{100h} , W	0.570	0.502	0.539
Power losses P_{200h} , W	0.595	0.518	0.556
Power losses P_{300h} , W	0.586	0.509	0.553
Power losses P_{400h} , W	0.593	0.515	0.558
Power losses P_{500h} , W	0.562	0.492	0.522
Power losses P_{600h} , W	0.575	0.500	0.508
Power losses P_{700h} , W	0.567	0.494	0.523
Power losses P_{800h} , W	0.559	0.489	0.518
Power losses P_{900h} , W	0.587	0.508	0.537
Power losses P_{end} , 1000+8h,W	0.557	0.484	0.502
P_{min} , W	0.557	0.484	0.502
Any increase of power losses from P_{min} during the remaining test period, P_{max}	0.557	0.484	0.502
$P_{all,max}$, W	0.595	0.523	0.586
$P_{max} / 1.3P_{min}$	0.769	0.770	0.770
$P_{all,max} / 1.1 P_{start}$	0.917	0.910	0.909

Note: (1) Because $P_{max} \leq 1.3P_{min}$, $P_{all,max} \leq 1.1P_{start}$, the samples fulfilled the requirements.
(2) The temperature of blocks: 115 ± 4 °C.

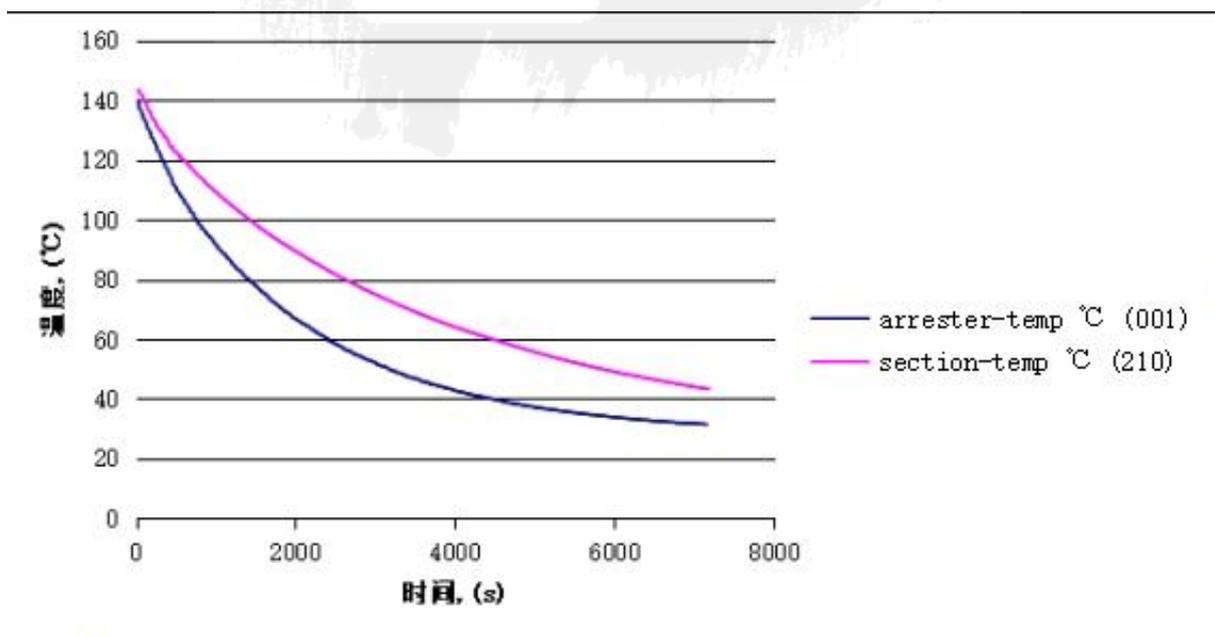
Fig 2 The cooling curve for the section and arrester

Requirements of standards: the MO resistors in the sample shall be heated to 140°C by the application of power-frequency voltage. When the temperature is reached, the voltage source shall be disconnected and the cooling time curve shall be determined. At any time, the measured cooling curve of section falls shall above the measured cooling curve of the arrester.

Test data: Fulfilled the requirements, the test waveform was shown in fig 2.

7	Residual voltage test	Lightning impulse	$\leq 134.0\text{kV}_p$	125.39kV_p	Pass
		Switching impulse	$\leq 114.0\text{kV}_p$	99.89kV_p	
		Steep current	$\leq 154.0\text{kV}_p$	132.53kV_p	
8	Repetitive charge transfer withstand test	10 samples should withstand 20 times 2ms long-duration current impulse and the charge value should not less than 0.3C.	$0.330\text{C} \sim 0.340\text{C}$	Pass	
9	Test to verify long term stability under continuous operating voltage	The accelerated ageing test of resistors should be carried out according to the specified procedure.	$P_{\text{max}} \leq 1.3P_{\text{min}}$, $P_{\text{all.max}} \leq 1.1P_{\text{start}}$; the samples fulfilled the requirements.	Pass	
10	Heat dissipation behavior verification test	The test section is for all instants during the cooling period have a temperature higher than the complete arrester.	Fulfilled the requirements. See fig 2.	Pass

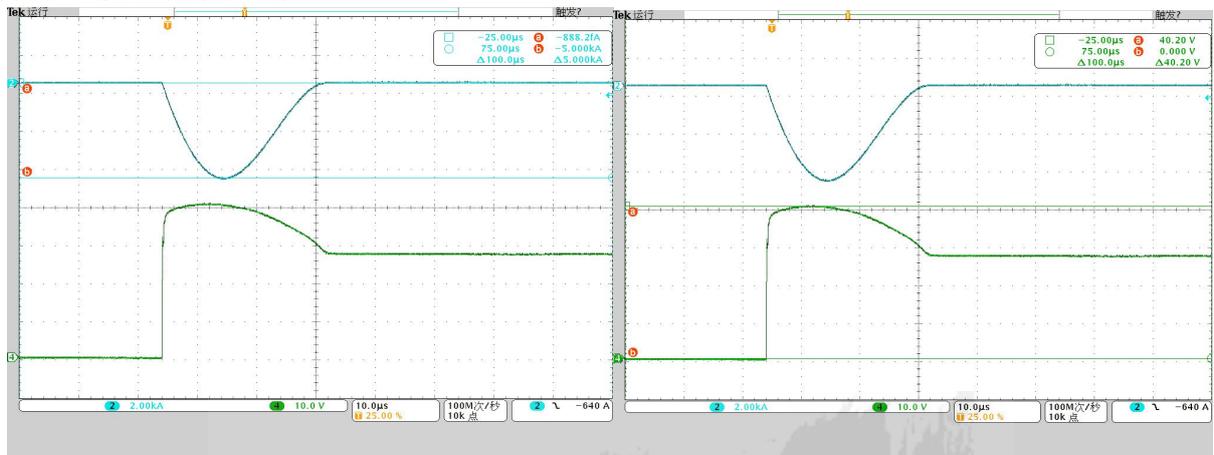
Fig C.1 Lightning impulse current and residual voltage waveform (sample 301, shunt 0.025V/A, divider $K_d=206.8$)

7.1 Lightning impulse current residual voltage test

Samples			301	302	303
Resistor	U_{1mADC}	kV	5.07	5.07	5.07
	8/20 μ s, 2.5kA	kV _p	7.82	7.80	7.81
	8/20 μ s, 5kA	kV _p	8.31	8.30	8.31
	8/20 μ s, 10kA	kV _p	9.05	9.03	9.03
	U_{5kA}/U_{1mADC}	-	1.64	1.64	1.64
Complete arrester	U_{1mADC}	kV	$73.0 \leq U_{1mADC} \leq 76.5$		
	Scale coefficient	-	15.09	15.09	15.09
	8/20 μ s, 2.5kA	kV _p	117.99	117.69	117.84
	8/20 μ s, 5kA	kV _p	125.39	125.24	125.39
	8/20 μ s, 10kA	kV _p	136.55	136.25	136.25
	Lightning impulse protection level	kV _p	125.39		
	Specified value	kV _p	≤ 134.0

Note 1: Shunt 0.025 V/A, divider $K_d=206.8$

Fulfilled the requirements. Test waveform is shown in appendix C fig C.1~ fig C.3.

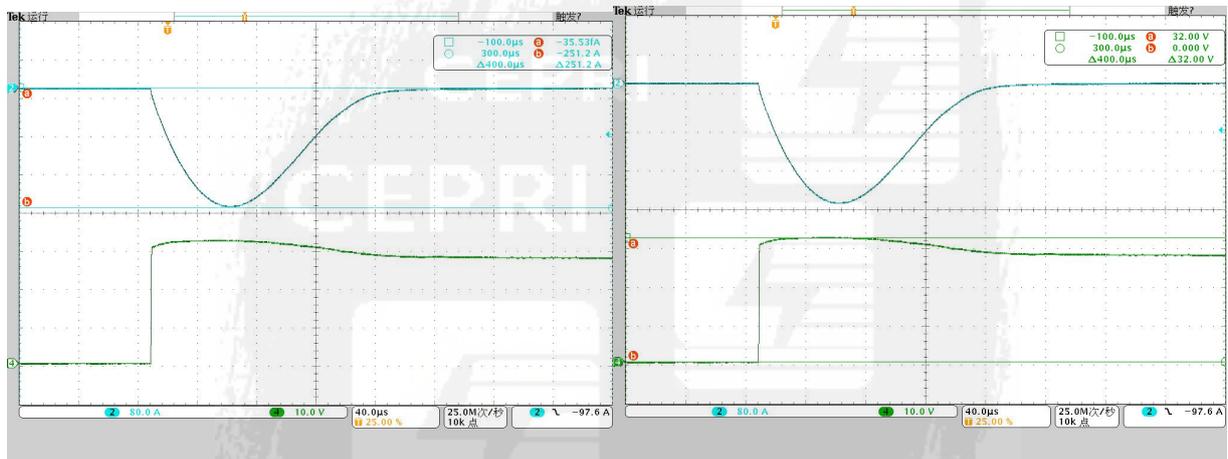
Fig C.2 Switching impulse current and residual voltage waveform (sample 301, shunt 0.025V/A, divider $K_d=206.8$)

7.2 Switching impulse current residual voltage test

Samples			301	302	303
Resistor	Residual voltage at 250A	kV _p	6.62	6.61	6.61
Complete arrester	Test value	kV _p	99.89	99.74	99.74
	Switching impulse current residual voltage	kV _p	99.89		
	Specified value	kV _p	≤ 114.0

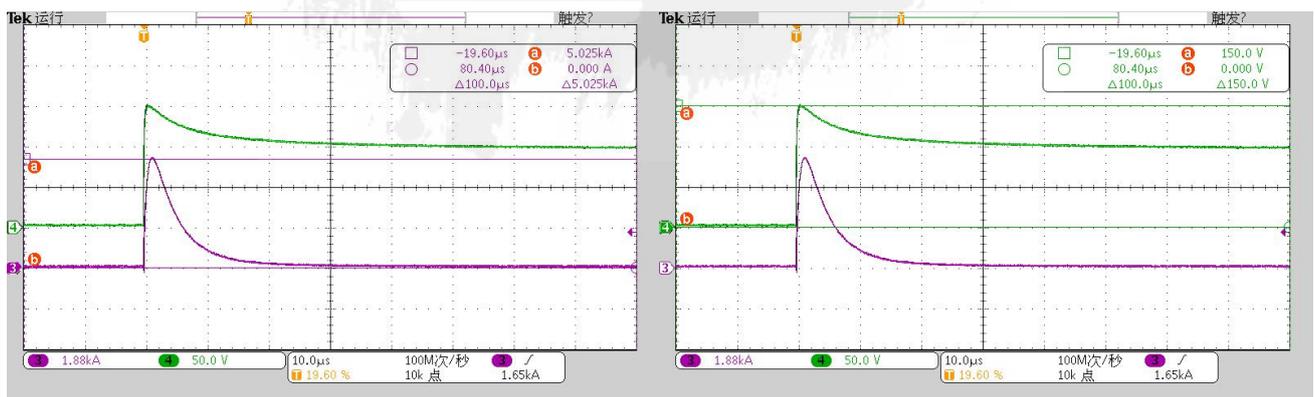
Fig C.3 Step impulse current and residual voltage waveform (sample 301, shunt 0.0267V/A, divider $K_d=59.8$)

7.3 Steep current impulse residual voltage test

Samples			301	302	303
Resistor	5 kA U_{res1}	kV _p	8.97	8.98	8.96
	5 kA U_{res2}	kV _p	0.23		
	U_{res2}/U_{res1}	%	2.6	2.6	2.6
	$U_{res1}-U_{res2}$	kV _p	8.74	8.75	8.73
Complete arrester	Scale coefficient	-	15.09	15.09	15.09
	Residual voltage for the arrester	kV _p	131.88	132.03	131.72
	Inductance per unit length	μ H/m	0.3		
	Height without resistors	m	$0.454-(0.024 \times 5)=0.334$		
	Inductive voltage correction	kV _p	$0.3 \times 0.334 \times 5=0.5$		
	After correction	kV _p	132.38	132.53	132.23
	Residual voltage for the arrester after correction	kV _p	132.53		
Specified value	kV _p	≤ 154.0

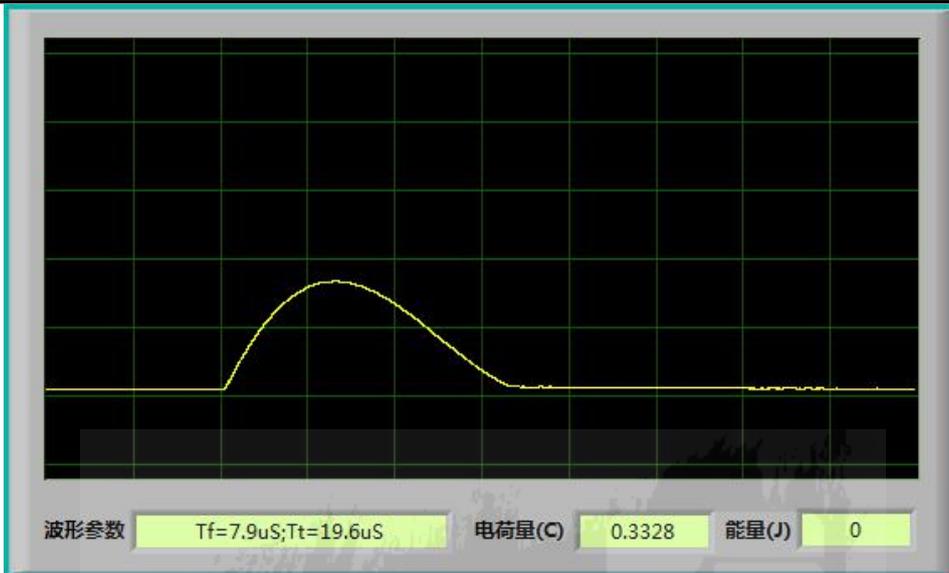
Fig C.4 The 1st time of sample 304, Repetitive charge transfer withstand, 0.00192V/A

Requirements of standards: The samples should withstand more than 0.3C by 8/20us current impulse for 20 times, and after test, have no breakdown or flashover or breakage, the change of residual voltage within $\pm 5\%$, the change of reference voltage within $\pm 5\%$, also should withstand capability to one 8/20us current impulse of at least 0.5 kA/cm² peak current density or 2 times I_n , whichever is lower.

Test data: Fulfilled the requirements, the test waveforms were shown in appendix C fig C.4.

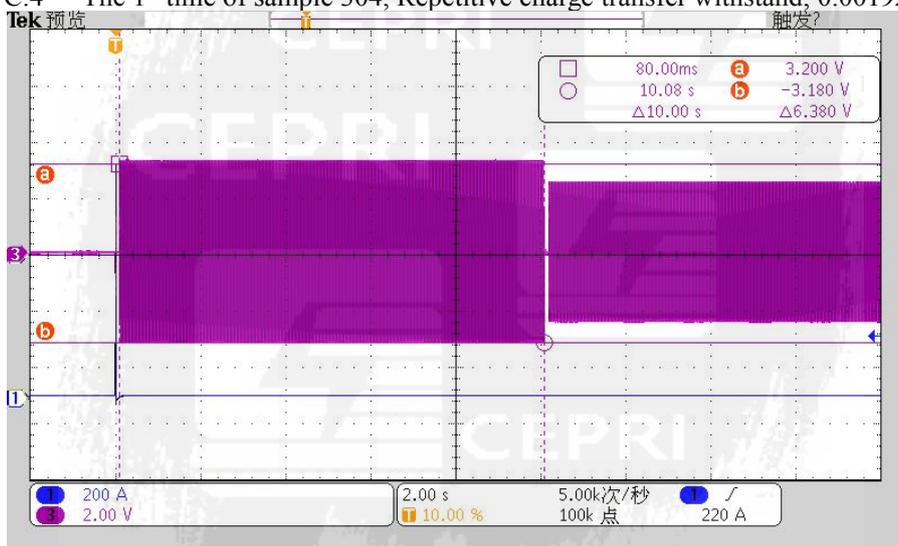
Fig C.5 Operating duty waveform, sample 201, $K_d=1590$

Test Report		Power Industry Quality Inspection and Test Center for Electric Equipment		CEPRI-EETC02-2022-0036(E) Total 20 Page 11		
11 Operating duty test						
Samples: 3 thermally prorated sections (201~203)						
Requirements of standards: 3 thermally prorated sections should pass the high current impulse operating duty test.						
Test data: Fulfilled the requirements, the test waveforms were shown in appendix C fig C.5.						
Samples		201	202	203		
U _{1mADC} , kV		5.11	5.11	5.12		
U _{sr} , kV _{rms}		3.57	3.57	3.57		
U _{sc} , kV _{rms}		2.86	2.86	2.86		
8/20μs, U _{5kA} ,before, kV		8.43	8.42	8.46		
Conditioning test	1 st high current impulse, kA		65.6	64.8	65.2	
	2 nd high current impulse, kA		65.2	65.5	64.9	
preheated samples		preheated samples to 85.0°C±3°C				
Rated thermal energy injection, Q _{th}	Lightning current impulse	1 st Q _{th} ,C	0.362	0.365	0.361	
		2 nd Q _{th} ,C	0.358	0.361	0.356

Q _{th} rating (2 times), C		0.720	0.726	0.717	
Applied voltage after the 3 rd impulse	Time	Req.	as short as possible (within 100ms)			
		Actual	86	84	84	
	Applied voltage and duration	U [*] _{sr} , kV _{rms}		3.57	3.57	3.57
		Duration, s		10	10	10
		U [*] _{sc} , kV _{rms}		2.86	2.86	2.86
Duration, min		30	30	30		
Power loss, W	1 s		4.27	4.63	4.37	
	5 min		2.51	2.68	2.56	
	10 min		2.02	2.22	2.11	
	15 min		1.81	2.01	2.01	
	20 min		1.73	1.85	1.93	
	25 min		1.65	1.78	1.88	
	30 min		1.62	1.75	1.86	
Samples cooled to		cooled to ambient 20°C±15°C				
8/20μs, U _{5kA} ,after, kV		8.48	8.51	8.53		
Variability of the residual voltage, %		+0.59	+1.07	+0.83		
Visual inspection		No puncture, flashover, cracking or other significant damage

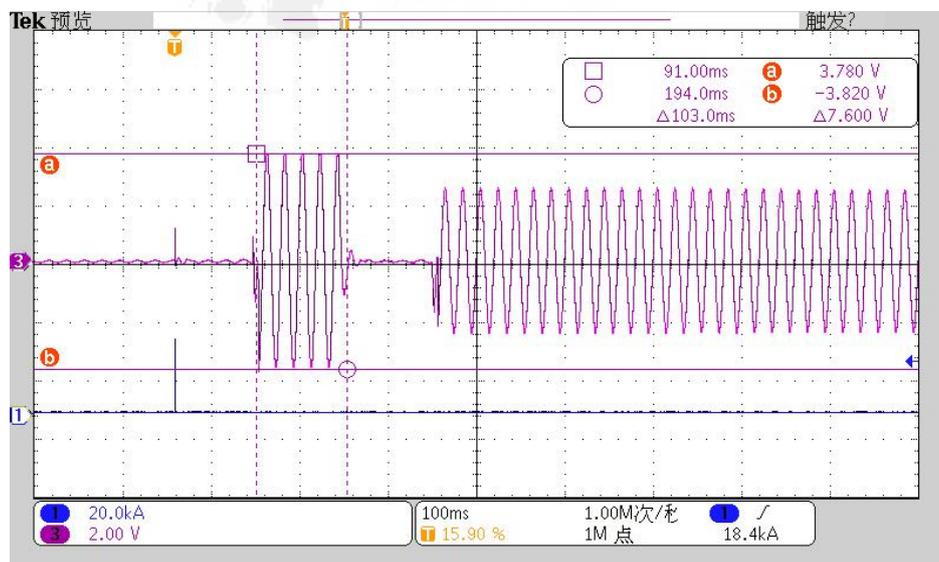
Fig C.6 Power-frequency voltage-versus-time test waveform, sample 204, $K_d=1590$

12.1 Power-frequency voltage-versus-time test data (with prior duty)

Samples			204	205	206	207
U _{1mADC} , kV			5.12	5.13	5.13	5.14
U _{sr} , kV _{rms}			3.58	3.58	3.58	3.59
U _{sc} , kV _{rms}			2.86	2.87	2.87	2.87
8/20μs, U _{5kA} , before, kV			8.45	8.47	8.48	8.48
preheated samples			preheated samples to 85°C±3°C			
2ms long-duration current impulse	1 st impulse	Q _{th} , C	0.363	0.361	0.359	0.365
	2 nd impulse	Q _{th} , C	0.368	0.362	0.362	0.363
	Q _{th} rating (2 times), C		0.731	0.723	0.721	0.728
Applied voltage after the 3 rd impulse	Time	Req.	as short as possible (within 100ms)			
		Actual	84	86	86	88
	Applied voltage and duration	U [*] _{sr} , kV _{rms}	4.29	4.12	3.94	3.59
		TOV scale	1.20	1.15	1.10	1.00
		Duration, s	0.1	1.10	10.1	1200
		U [*] _{sc} , kV _{rms}	2.86	2.87	2.87	2.87
		Duration, min	30	30	30	30
Power loss, W	1 s	8.21	6.58	4.96	4.17	
	5 min	5.36	5.06	2.79	2.62	
	10 min	4.17	3.95	2.53	2.18	
	15 min	3.39	3.07	2.31	1.95	
	20 min	2.75	2.66	2.24	1.95	
	25 min	2.51	2.47	2.18	1.83

30 min	2.46	2.41	2.16	1.80	
Samples cooled to			cooled to ambient 20°C±15°C			
8/20μs, U _{5kA} , after, kV			8.57	8.53	8.57	8.55
Variability of the residual voltage, %			+1.42	+0.71	+1.06	+0.83
Visual inspection			No puncture, flashover, cracking or other significant damage			
Fulfilled the requirements, the test waveforms were shown in appendix C fig C.6~C.8.

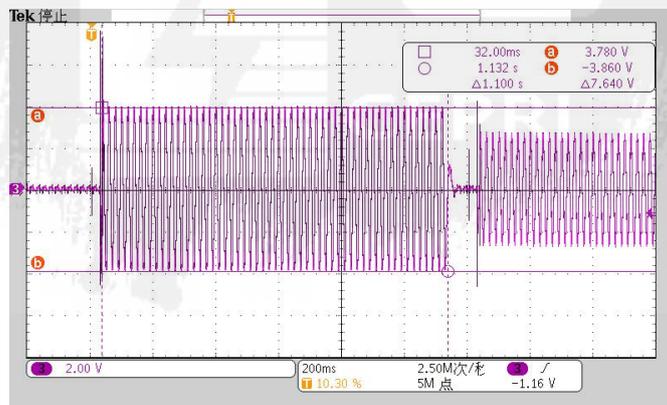
Fig C.9 Power-frequency voltage-versus-time test waveform, sample 208, $K_d=1590$

12.2 Power-frequency voltage-versus-time test data (without prior duty)

Samples		208	209	
U _{1mADC} , kV		5.12	5.12	
U _{sr} , kV _{rms}		3.58	3.58	
U _{sc} , kV _{rms}		2.86	2.86	
8/20μs, U _{5kA} ,before, kV		8.45	8.46	
preheated samples		preheated samples to 85.0°C±3°C		
Applied voltage	Applied voltage and duration	U _{sr} [*] , kV _{rms}	4.29	3.58
		TOV scale	1.20	1.00
		Duration, s	1.1	1200
		U _{sc} [*] , kV _{rms}	2.86	2.86
		Duration, min	30	30
Power loss, W	1 s	2.85	2.56	
	5 min	2.52	2.17	
	10 min	2.36	1.85	
	15 min	2.19	1.79	
	20 min	2.07	1.74	
	25 min	1.98	1.70	
	30 min	1.90	1.69	
Samples cooled to		cooled to ambient 20°C±15°C		
8/20μs, U _{5kA} ,after, kV		8.42	8.52	
Variability of the residual voltage, %		-0.36	+0.71	
Visual inspection		No puncture, flashover, cracking or other significant damage

Fulfilled the requirements, the test waveforms were shown in appendix C fig C.9.

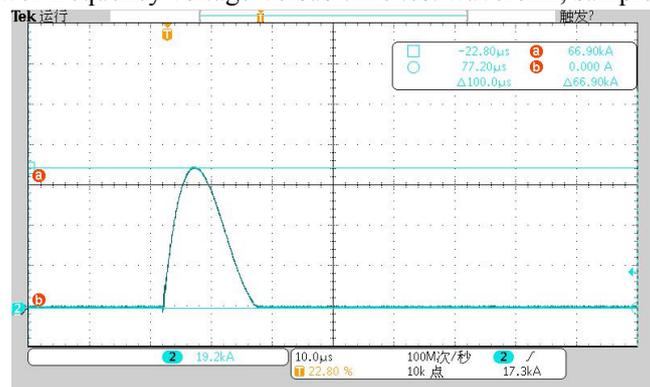
Fig C.10 Test to verify the dielectric withstand of the internal components of an arrester , sample 104

Requirements of standards: preheat the sample to 60°C, consists of one application of a 65kA high-current impulse.

There should be no evidence of a dielectric breakdown. The test waveforms were shown in appendix C fig C.10.

Sample	104		
U_{1mAAC} , kV	3.73		
8/20 μ s, U_{5kA} , before, kV	8.35		
preheated samples	preheated samples to 60°C±3°C		
high-current impulse, kA	66.90		
Samples cooled to	cooled to ambient 20°C±15°C		
8/20 μ s, U_{5kA} , after, kV	8.41		
Variability of the residual voltage, %	+0.72		
Visual inspection	The block can not remove from the section	8/20 μ s current impulse, 2 times	6.92 kA ($0.5kA/cm^2=0.5 \times 3.14 \times (4.2/2)^2=6.92kA$ which is lower than 2 times I_n)
		1 st impulse, kA _p	6.95
		2 nd impulse, kA _p	6.98
		Curve check	No puncture, flashover, cracking or other significant damage

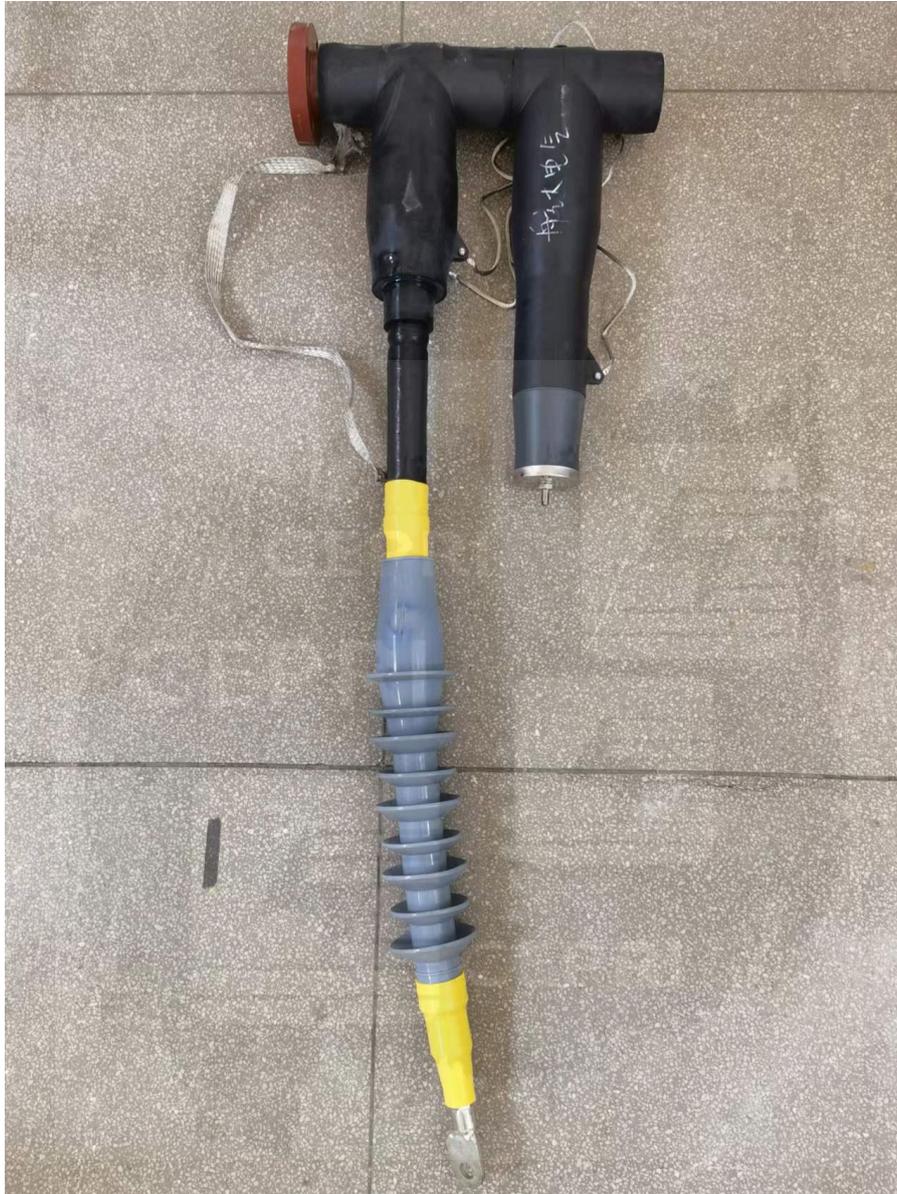
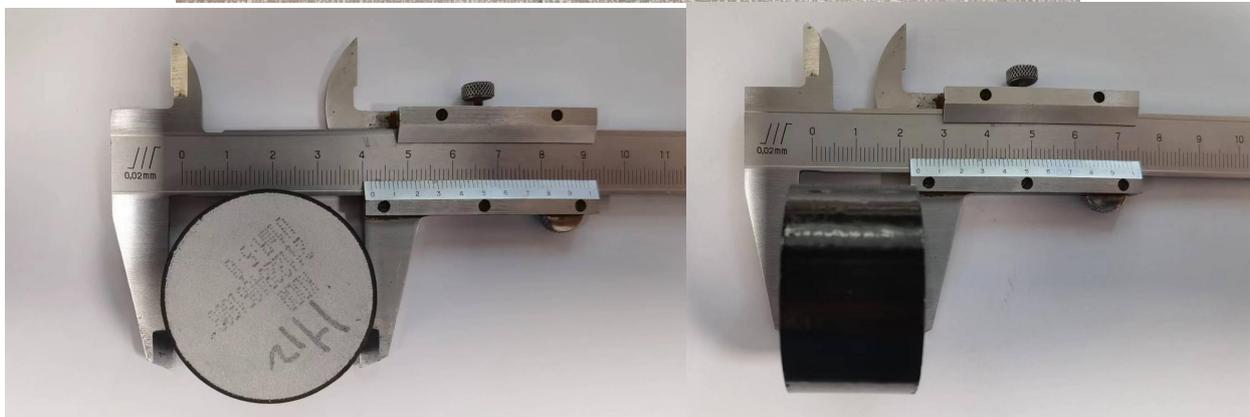
Fig D1: GHD-35BLQ-51/134 type arrester and resistor

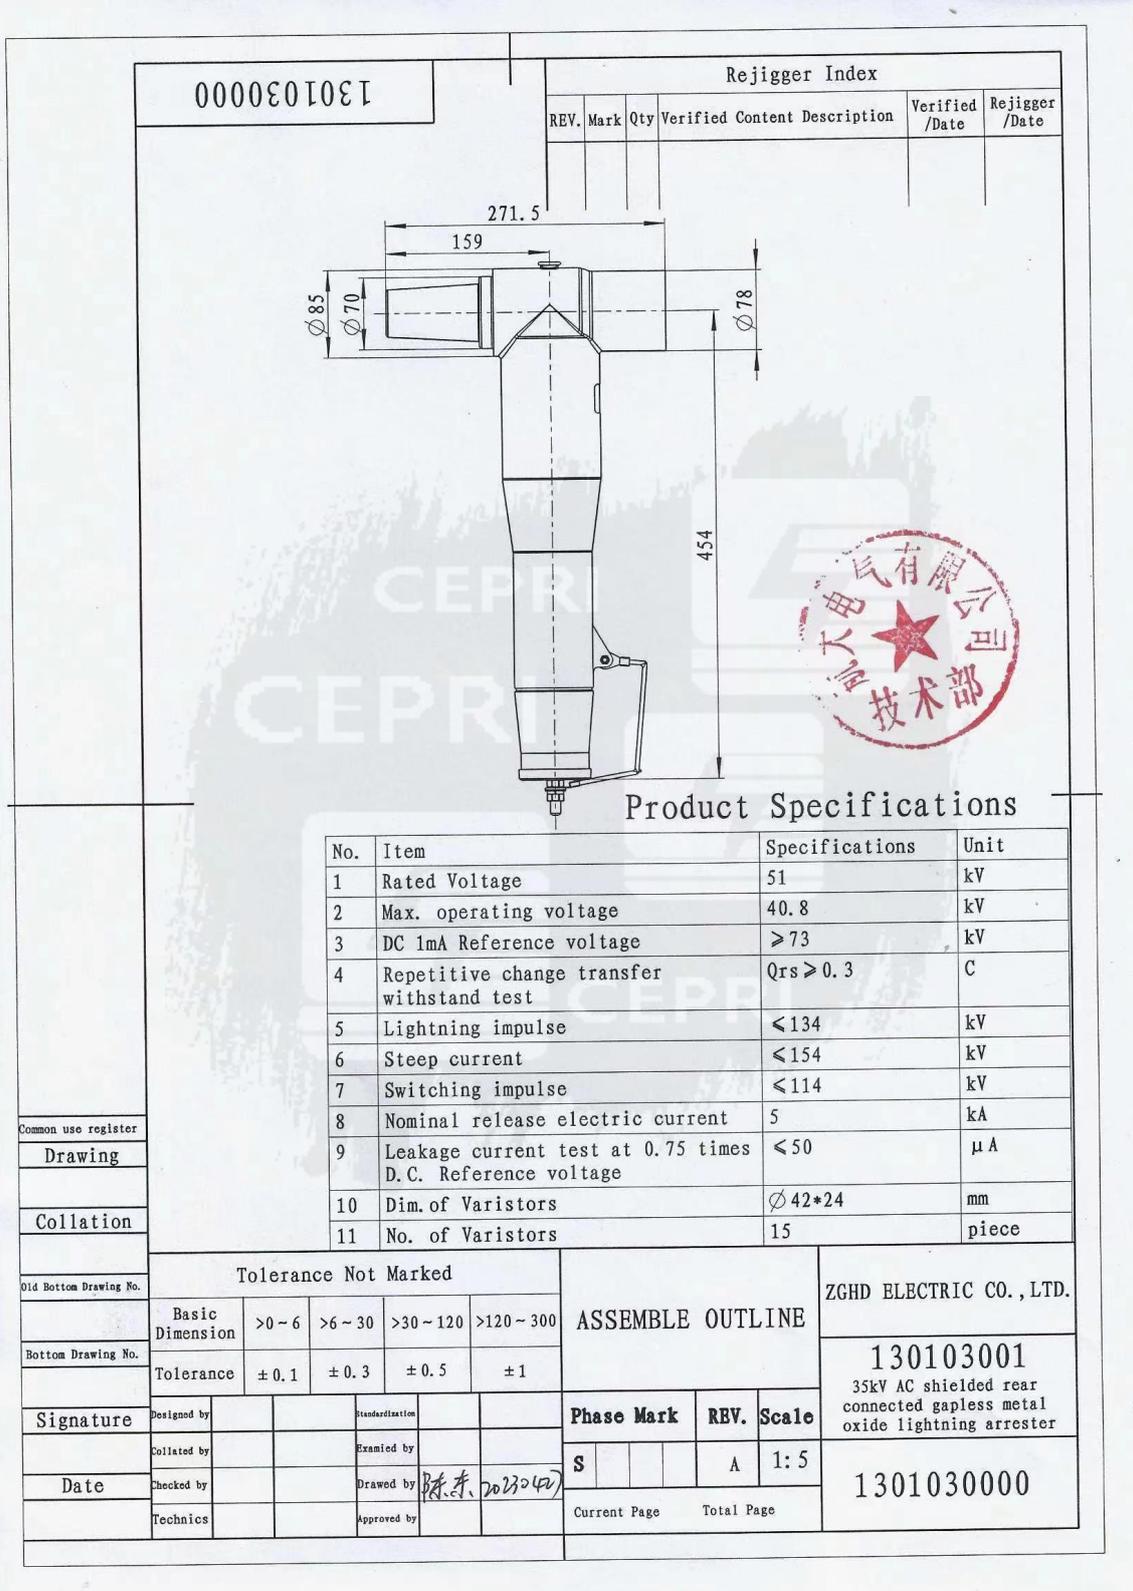
Fig D2 : Dimensional drawing of GHD-35BLQ-51/134
